Melaka Streetscape Evolution: The six years journey

Shahrul Yani Said, Zalina Samadi

The study looks at the six years changes made to the streetscape of Melaka to adapt to the requirement of a better quality of life for the occupants. The different approach to regeneration scheme of Melaka could provide insight into modern demands for the city. The idea of integrating all the streets within the historic core area to form a synchronised pedestrian route system is plausible as it will help the users to experience the historic area as a whole may portray the trend of local economic growth and provide opportunities for improvement of the area.

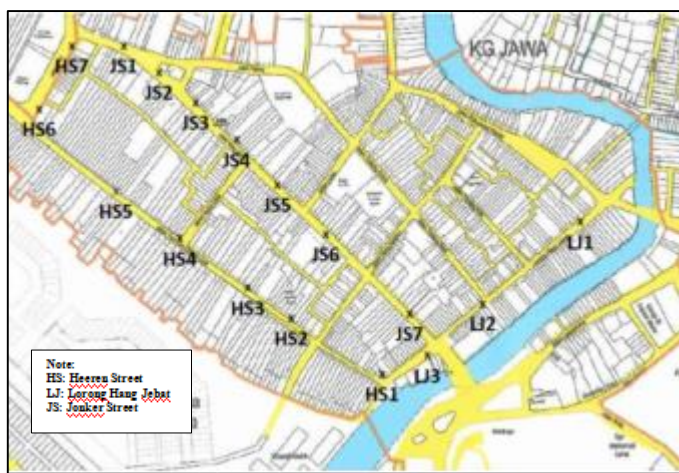
Figure 2: Assessment points for Environmental Quality and Streetscape

The fifteen elements above provide a quantitative value to the streetscape assessed. Seventeen (17) assessed points were used to score the environmental quality of the street (Figure 2). The points were the same standing point used in 2010 and 2013 assessments identified by the photos captured during the previous fieldworks. All the points were named according to the streets where the assessments were carried out (Table 2).

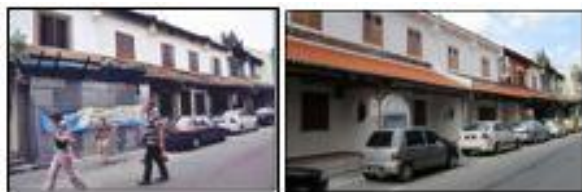
Figure 4 a & b: Heeren Street (HS4) in 2010 (left) and 2016 (right)

In the second assessment carried out in 2013, conservation work has not completed yet, which led to similar scores on the quality of the streetscape. However, the recent visit in January 2016 shows a major improvement to the streetscape, where most of the conservation work has completed (Figure 4b), thus the better score. However, there is also a fluctuation of townscape quality score at the very end of Lorong Hang Jebat because of recent conservation project carried out in the area (Figure 5). The restricted view caused

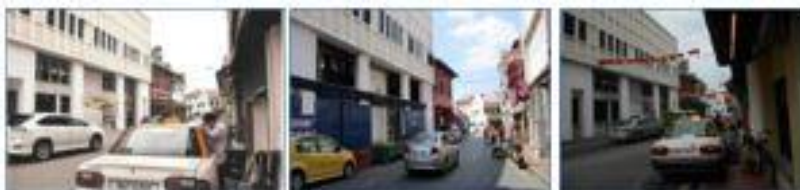
Figure 5: Changes to Lorong Hang Jebat (LJ3) 2010 (left) 2013 (middle) 2016(right)

lower score for accessibility, vitality, safety and coherence.
